INFLUENCE OF WEATHERING AND STRESS RELIEF ON GEOTECHNICAL PROPERTIES OF ROADCUT MASS AND EMBANKMENT FILL ON ST. VINCENT AND ST. LUCIA

Thesis submitted to the Faculty of Geo-Information Science and
Earth Observation of the University of Twente in partial fulfilment of the
requirements for the degree of Master of Science in Geo-information
Science and Earth Observation.

Specialization: Applied Earth Sciences (Engineering geology)

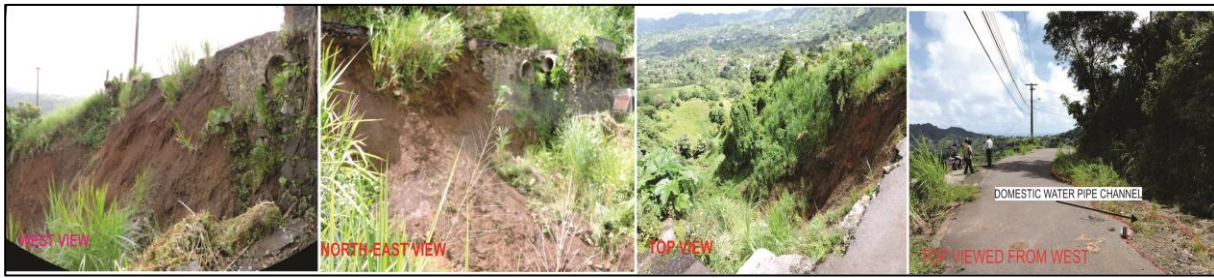
Figure 15: St Vincent, Belmont embankment, viewed from west, north-east and top (photos: Mulenga, 24/09/2014, 14:17pm)

showed a slight tilt towards the slope face. Progressively, this might result into another slide or slip (fig 15).

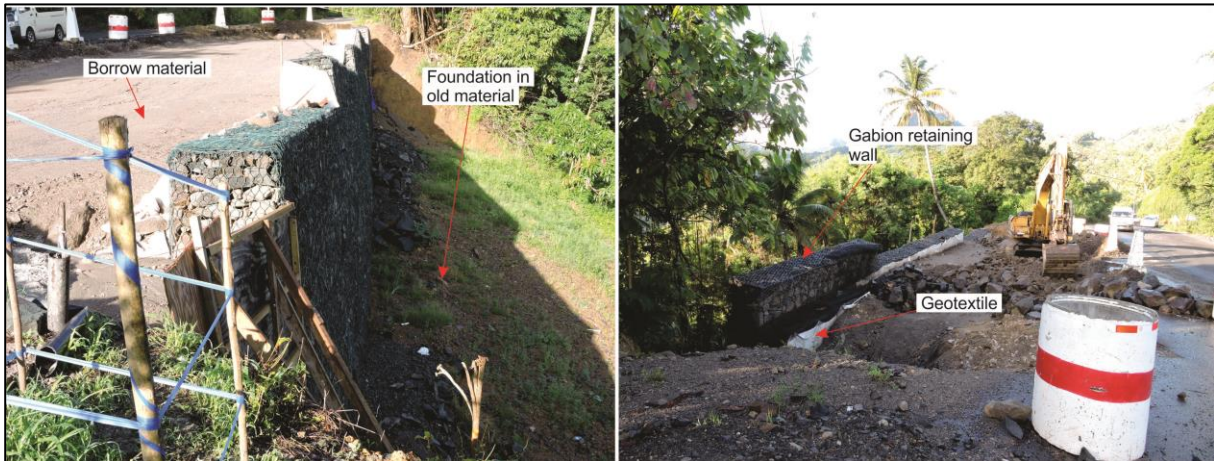
Figure 17: St Lucia, Barre de l'Isle embankment under rehabilitation (photo: Mulenga, 10/10/2014, 07:20 am).

were collected. From field observation, initial construction of these embankments was done by cut and fill methods, and hence, there mode of failure was similar. Cut slopes in the area are covered by thick vegetation canopies resulting into poor accessibility. Vegetation canopies along the slopes are likely to trap water, necessitate ingress into the embankments mass. No intact materials were observed in the embankments, despite the initial method of construction being non-selective. The likelihood is that the material has undergone weathering and has led to the breakdown and decay of materials with time.

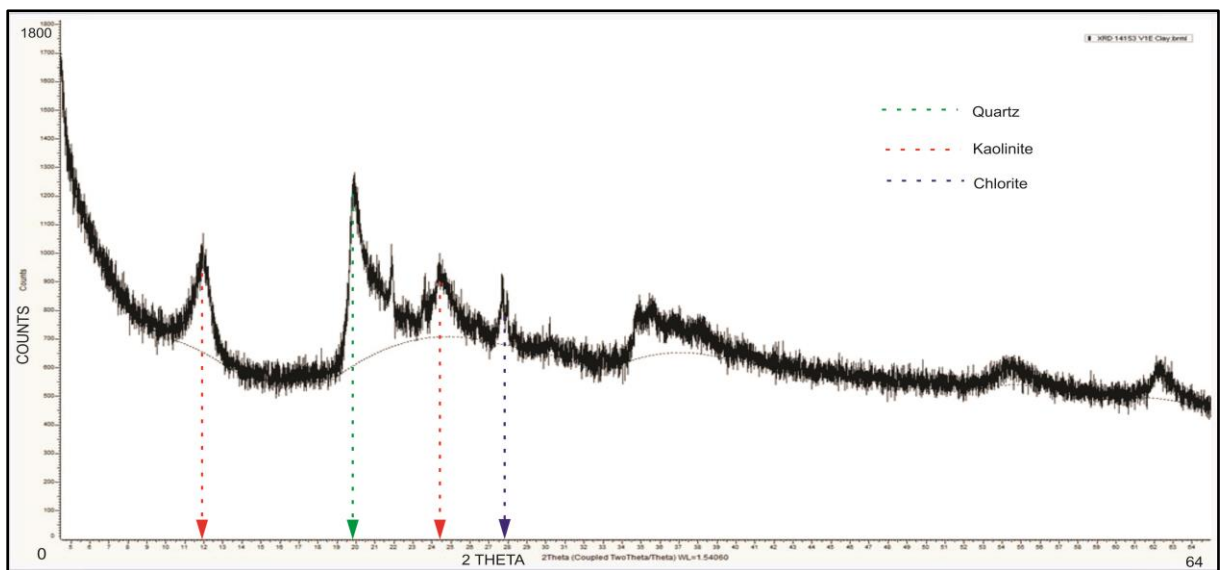
Figure 23: X-ray diffractogram (XRD) for embankment fill material, Belmont embankment (St Vincent) (the dashed lines on the peaks have no meaning and are only for identification, red for kaolinite peak, green for quartz peak, and purple for chlorite peak).

Figure 23 of embankment fill material show the presence of kaolinite and chlorite, while figure 35 (appendix 2) shows the presence of kaolinite and montmorillonite (smectite) clay minerals. Chlorite clay mineral is a weathering product of basalt and ultrabasic rocks (Tong, 2000; Velde & Meunier, 2008). It is considered as a pore-filling clay mineral, and occurs as individual plates of cabbage head like morphotypes (Ahmed, 2008). Montmorillonite is an alteration product of volcanic tuffs and ash. All of these clay minerals are products of weathering (table 2, chapter 2.1.3), and their presence indicates that the material has undergone weathering. These clay minerals as products of weathering have an effect on the embankment stability in terms of changes caused in fill material permeability and porosity (chapter 2.1.5).

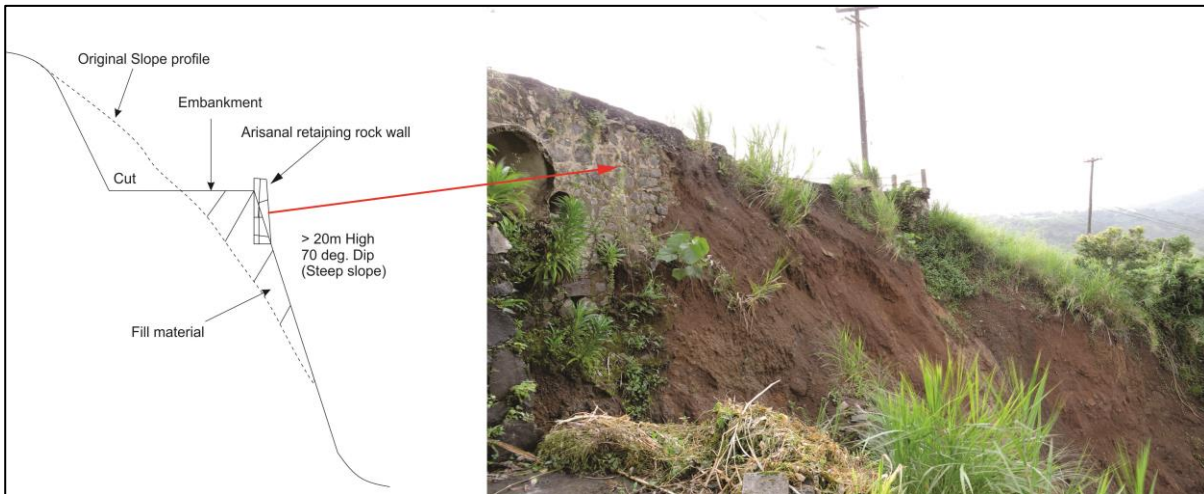
Figure 28: Belmont embankment showing the retaining rock wall (St Vincent).

From table 9, chapter 6.2.2.2, it can be seen that increasing the factor of safety from 0.9 to 1.5 and then 2.0 leads to a decline in cohesion and friction angle developed along the shear plane, and the allowable height. The critical height, which is the maximum height at which the critical equilibrium occurs in the embankment slope, is 29.8 meters, and it is calculated based on the effective cohesion and internal friction angle. A factor of safety 0.9 for the embankment is assumed to have failed, since the calculated allowable height is above the critical height. At this height, the calculated cohesion is less than the estimate value, while the angle of internal friction is slightly higher than the estimate value. This scenario results into a definite failure since the allowable value of height is also higher than the critical value. The acceptable design factor of safety 1.5 gives the maximum allowable height of 18.8 meters. At this height, the slope is expected to be stable. The factor of safety 2 at which the embankment slope would be very stable gives the lowest allowable height of 9.3 meters. The embankment was constructed at a height of about 25 meters well above the calculated maximum critical and allowable height of failure. The material was probably held in place by the artisanal retaining wall built on the fill material repose slope surface (Figure 28). This assertion is evident from the wall's remains still hanging on the embankment slope face, and the nearby intact embankment roads.

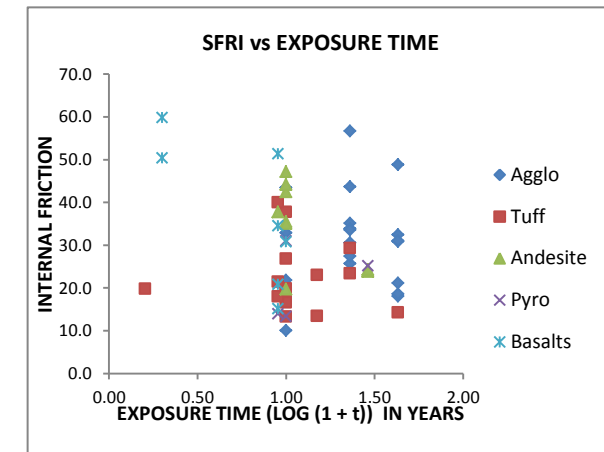
Figure 30: The effect of exposure time (in years) and logarithmic scale of exposure time on geotechnical properties of geological formations (the dashed lines between the makers have no meaning and are only for identification).

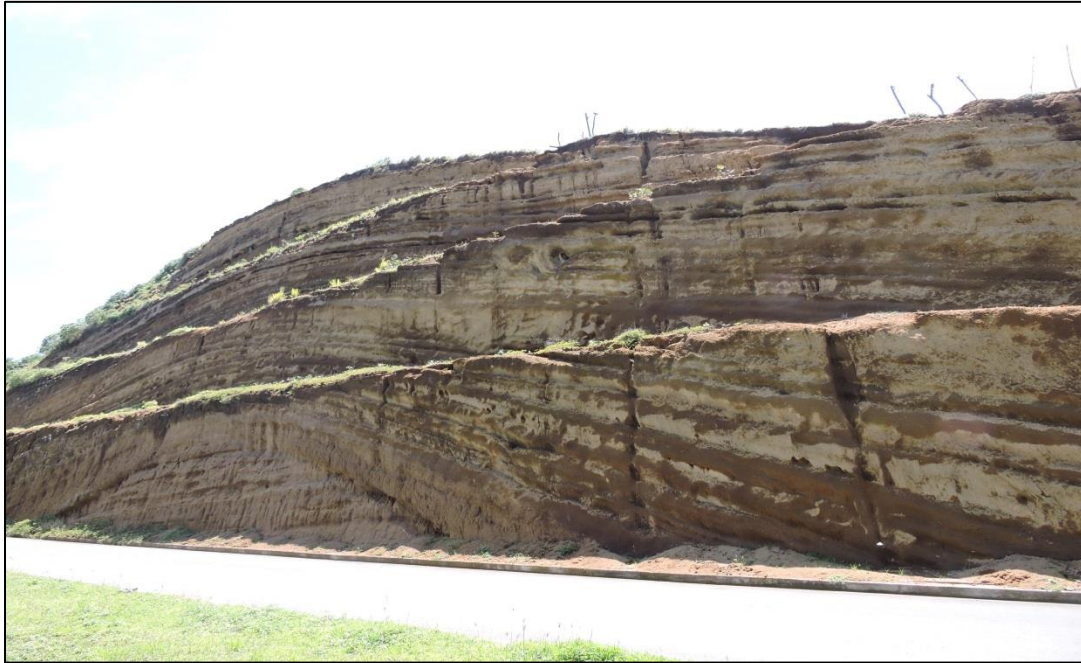
Figure 33: St Vincent, slope showing differential weathering due to lithological heterogeneity, east coast (Direction of view 035 degrees).

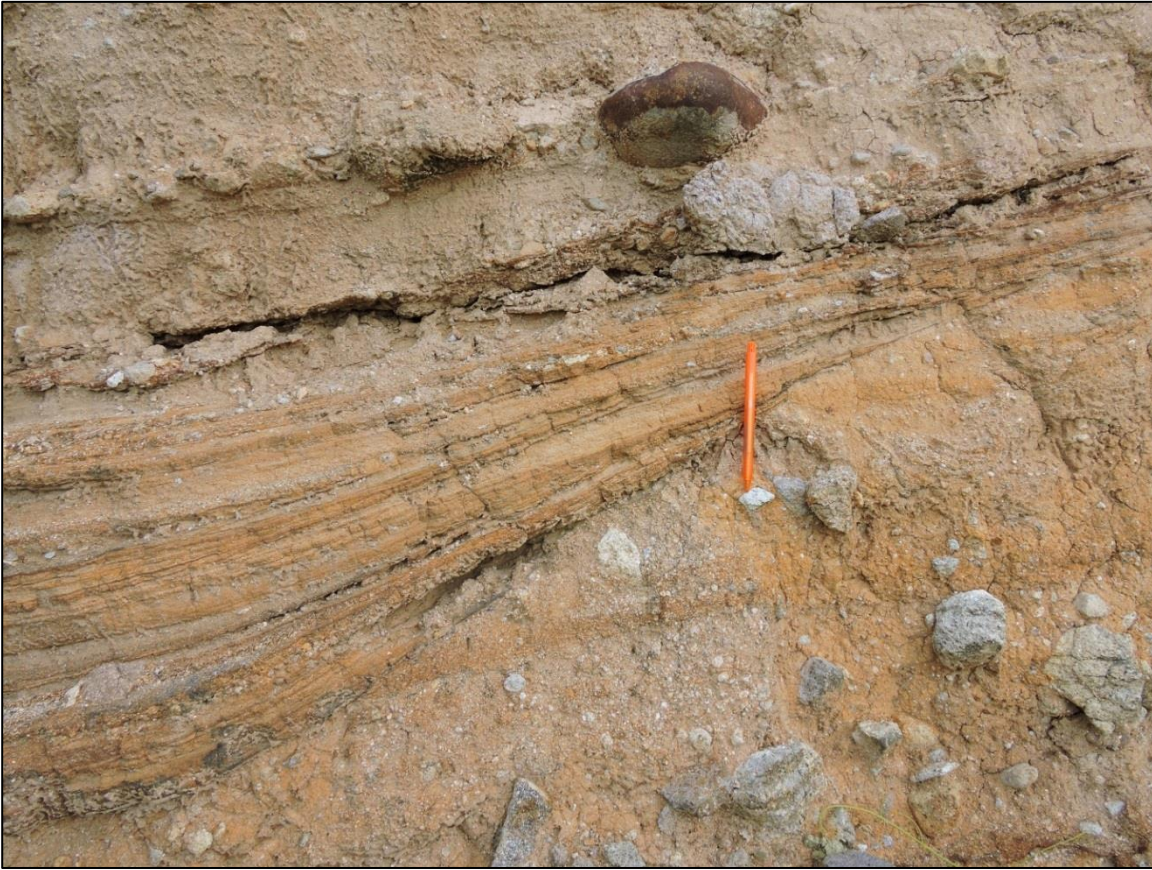
Figure 37: St Lucia, liesegang rings suggesting chemical weathering

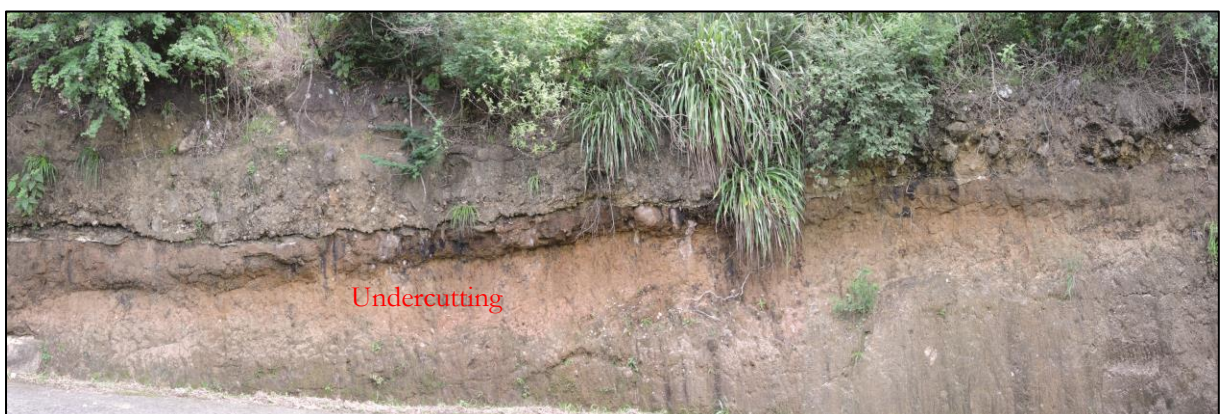
Figure 50: Cut slope L10

L10	<p><i>Location:</i> 708905E, 1537619N <i>Date & method of excavation:</i> 1992, Excavator <i>Geological formation:</i> Agglomerate tuffs, tuffs (southern series) <i>Accessibility:</i> Good <i>Geotechnical units:</i> 02</p>	<p>Intact rock strength (IRS) 3.125MPa; coarse grained, bedded and clastic, poorly sorted, clasts supported, Greyish –dark, brownish colours. Agglomerates, Tuff</p>	<p>Highly and completely weathered; 2.7m high; 30m length; Dip 82 degrees, Dip direction 37 degrees; variable discontinuity orientation, with spacing varying from 0.2m to 1.5m. persistence along strike from >0.1m to >10m and along dip >0.4m to >1m</p>
L11	<p><i>Location:</i> 712362E, 1543261N <i>Date & method of excavation:</i> 1972, Excavator <i>Geological formation:</i> Andesite Ash altered Andesite (Central series) <i>Accessibility:</i> Good <i>Geotechnical units:</i> 01</p>	<p>Intact rock strength (IRS) 150MPa; fine grained, bedded, poorly sorted, matrix supported, brownish-dark colour. Tuff</p>	<p>Slightly weathered; 3m high; 100m length; Dip 87 degrees, Dip direction 80 degrees; variable discontinuity orientation, with spacing varying from 0.14m to 1m. persistence along strike from >0.2m to >1m and along dip >0.2m to >2m</p>

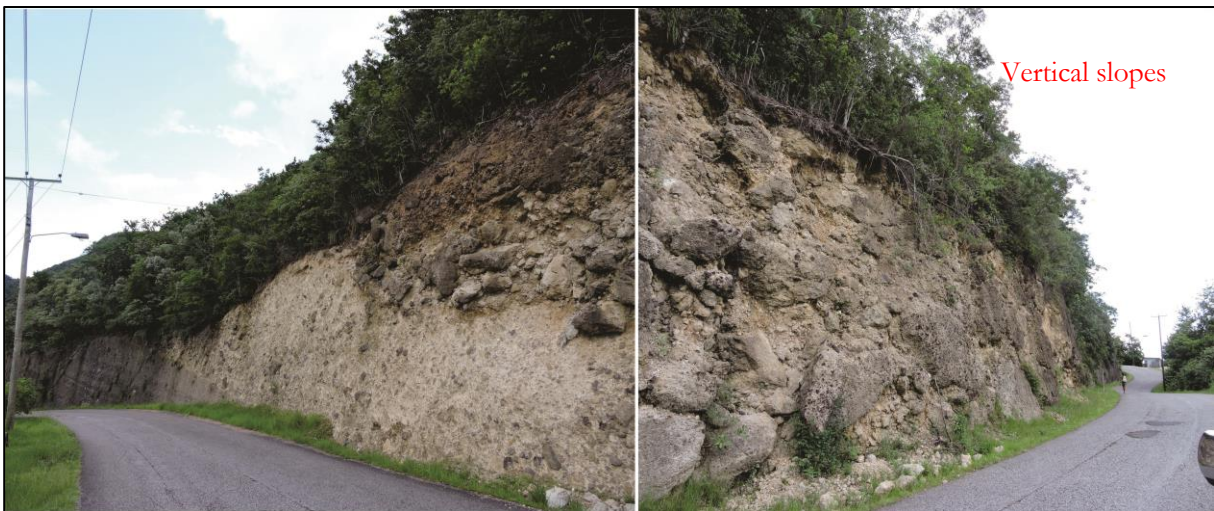
Figure 52: Cut slope L12

L12	<p><i>Location:</i> 710594E, 1533993N <i>Date & method of excavation:</i> 1992, Excavator <i>Geological formation:</i> Andesite Agglomerates (Central series) <i>Accessibility:</i> Good <i>Geotechnical units:</i> 02</p>	<p>Intact rock strength (IRS) 31.25MPa, coarse grained, massive clastic, poorly sorted, clasts supported, Greyish –dark colour. Agglomerates</p>	<p>Highly weathered; 5m high; 100m length; Dip /Dip direction: 81/233, 75/49 degrees; variable discontinuity orientation, with spacing varying from 0.1m to 1.2m. persistence along strike from >1m to >4m and along dip >0.2m to >3m</p>
